GeoScienceEd 7(3) (2026)

Jurnal Pendidikan, Sains, Geologi, dan Geofisika

Hydroclimatic Context and Deterministic Stability of Weathered Limestone Road-Cut Slopes along the Maros-Bone Corridor, Indonesia

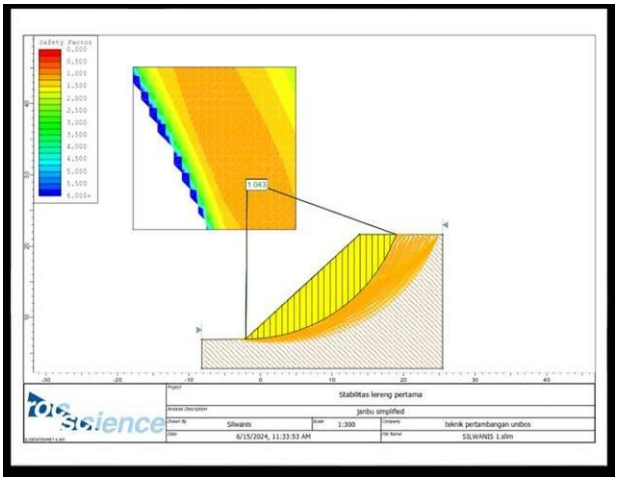
The Simplified Janbu analysis yielded a minimum factor of safety of 1.043 for Site 1 and 1.002 for Site 2. Both values indicate a very limited stability margin under the modeled static conditions. Site 2 is the more critical location because its factor of safety is only 0.002 above unity, meaning that the calculated resisting and driving conditions are almost balanced.

Figure 3. Simplified Janbu output for Site 1, showing a minimum factor of safety of 1.043.

At Site 1, the gentler slope is counterbalanced by stronger weathering, higher observed saturation ranges, and field evidence of water. The independent rainfall record strengthens the hydroclimatic interpretation: Maros received 3,336 mm of rainfall in 2023, with 94.1% concentrated between November and April and particularly high monthly totals in January and February (Badan Pusat Statistik Kabupaten Maros, 2024). In weathered limestone, such prolonged seasonal water input may sustain infiltration through pores,

The results justify prioritizing both locations for additional geotechnical assessment. Potential engineering measures include slope regrading, surface and subsurface drainage, erosion control, removal of loose weathered material, and retaining or reinforcement systems where required. However, stabilization should not be selected solely from the present deterministic factors of safety. Each candidate measure should be reanalyzed using revised geometry and hydrological assumptions, and the final design should satisfy the applicable Indonesian geotechnical requirements (Badan Standardisasi Nasional, 2017).

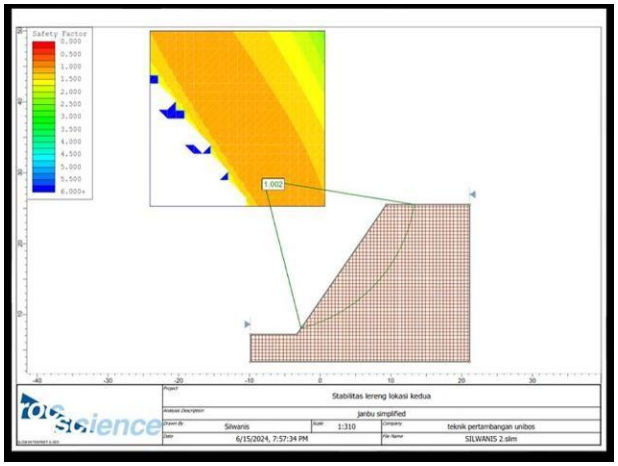
Figure 4. Simplified Janbu output for Site 2, showing a minimum factor of safety of 1.002.

The extremely small strength-stress difference at Site 2 (0.1072 kPa) indicates that modest changes in pore-water pressure, erosion, additional loading, or progressive weathering could alter the modeled condition. Studies that compare limit-equilibrium and finite-element methods show that marginal slopes benefit from multi-method evaluation because differences in assumed failure mechanism and stress redistribution may affect the predicted critical condition (Mebrahtu et al., 2022; Rahman et al., 2023; Garo et al., 2024). Hussen et al. (2024) further found that saturation and method choice can materially influence predicted road-slope performance.
